For the Love of Florida: The North Fork of the St. Lucie River

February 13, 2019

Gary Goforth, P.E., Ph.D.

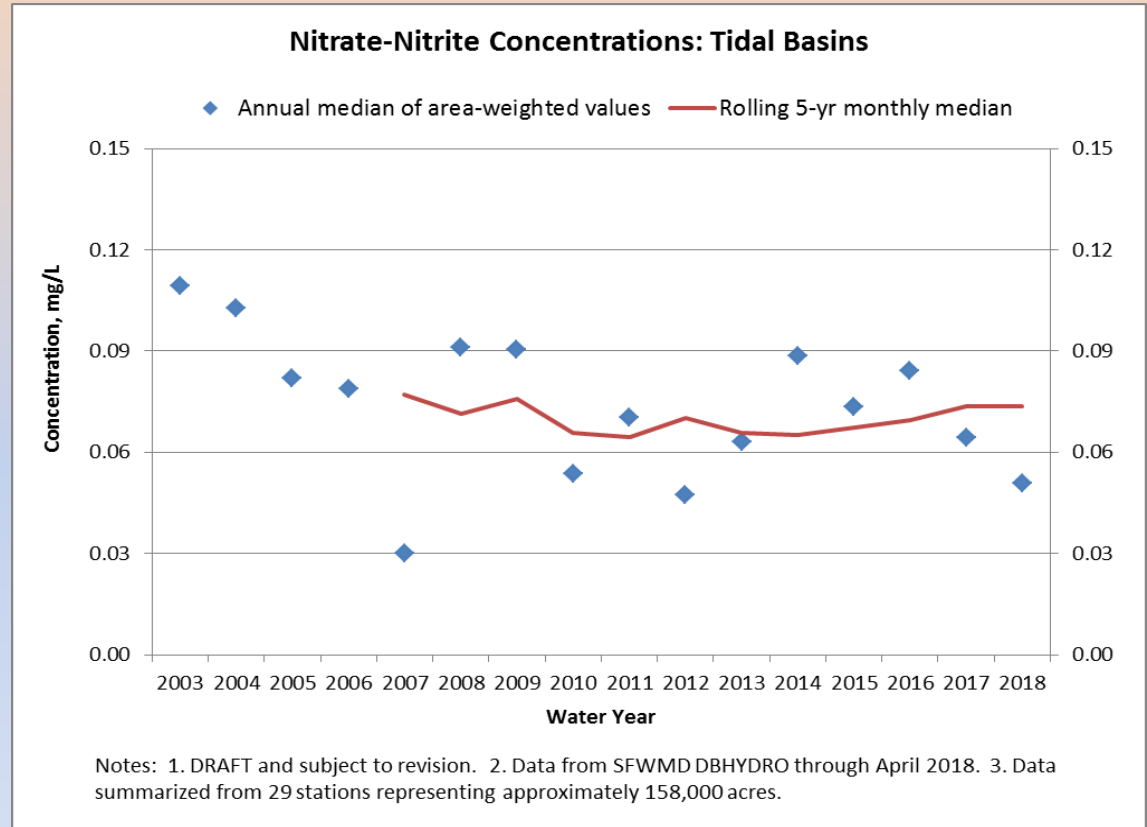
Septic Tanks – Contribution is Getting Smaller

Septic tanks are part of the loading problem

Estimated contribution remains below 10 percent of total nitrogen loading to estuary

Efforts by counties and municipalities are resulting in declining nitrogen levels

- Conversion of more than 8,000 septic tanks and 70 package treatment plants
- Active septic conversion program - \$155 million
